Roadway Condition Report Route 17 in Broome County

— March 1983

SUBJECT ROADWAY CONDITION REPORT
ROUTE 17 IN BROOME COUNTY

FROM L H. Moore, Technical Services Division, Rm. 210, Bldg. 7A *LHM*

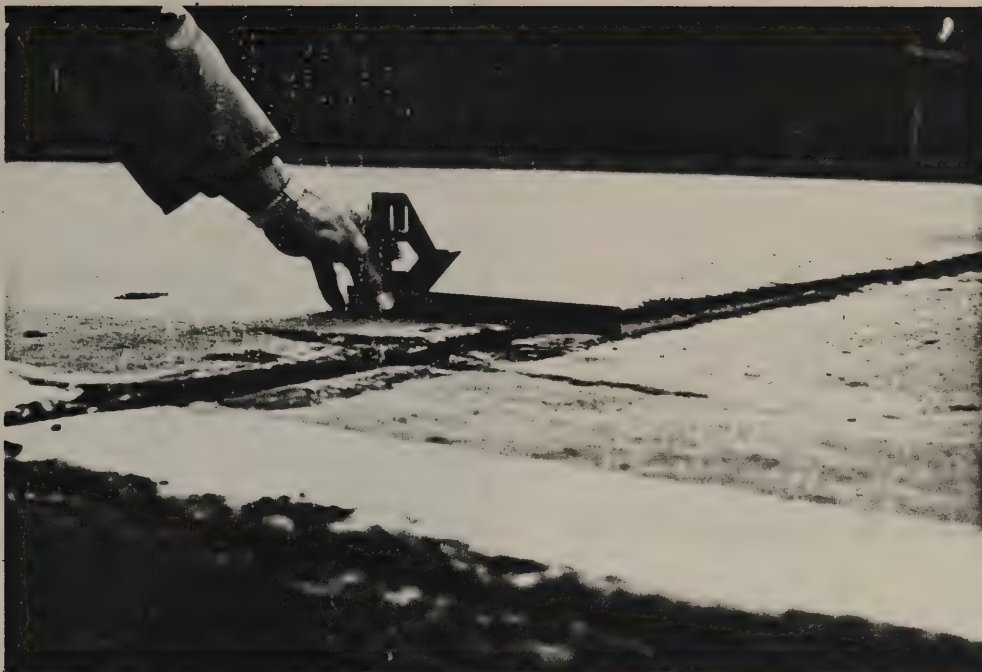
PHOTO 1
Transverse Joint Faulting

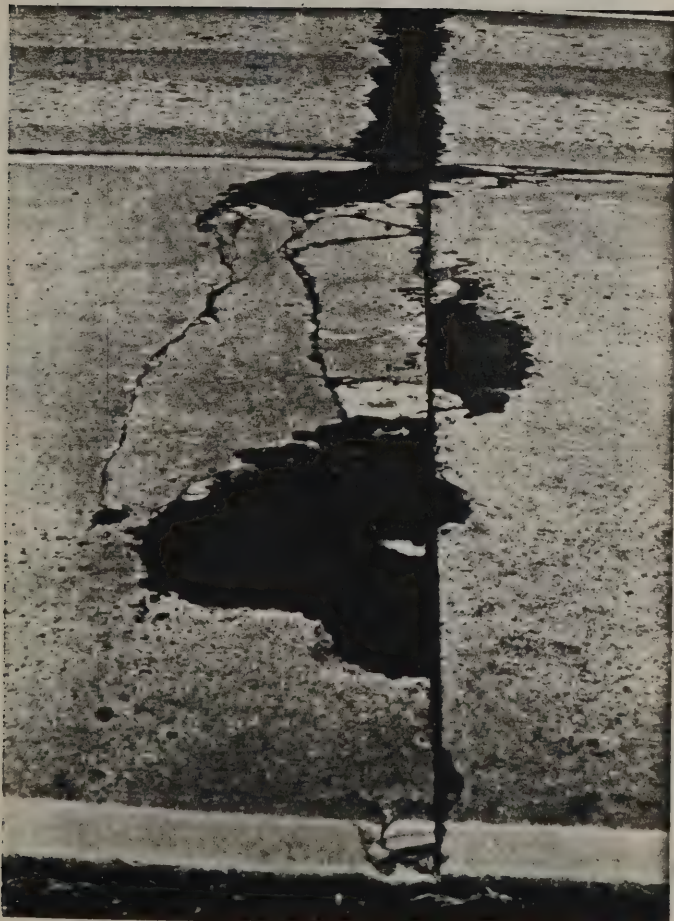
PHOTO 2
Major Transverse Joint
Spalling, Patched by
Maintenance Forces.

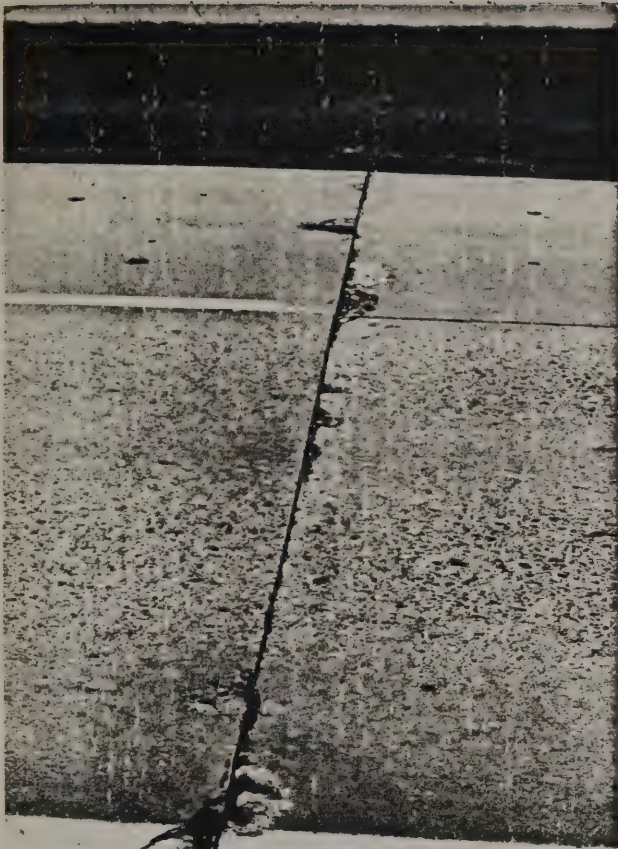
PHOTO 3

Minor Transverse Joint Spalling

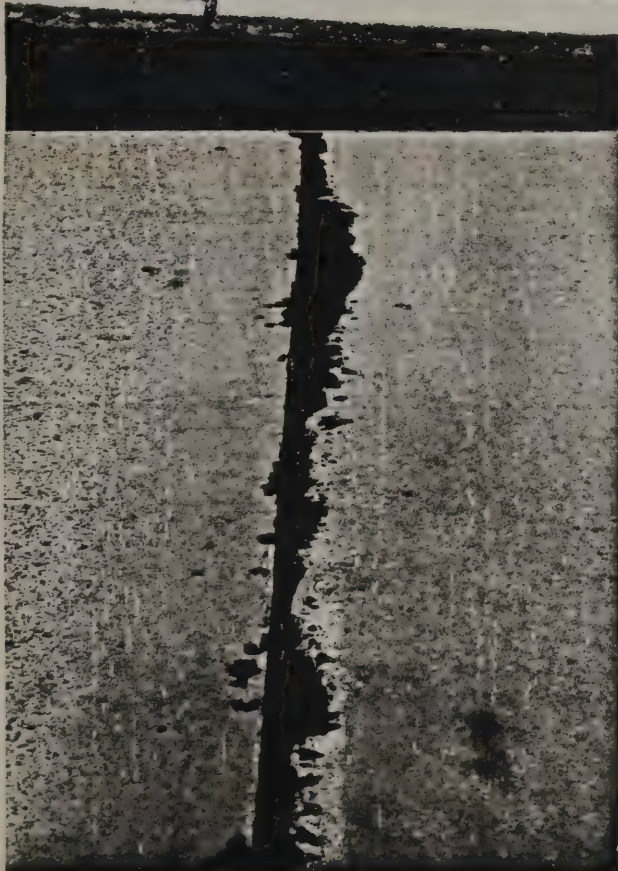
PHOTO 4

Major Longitudinal Joint
Spalling, Patched by
Maintenance Forces

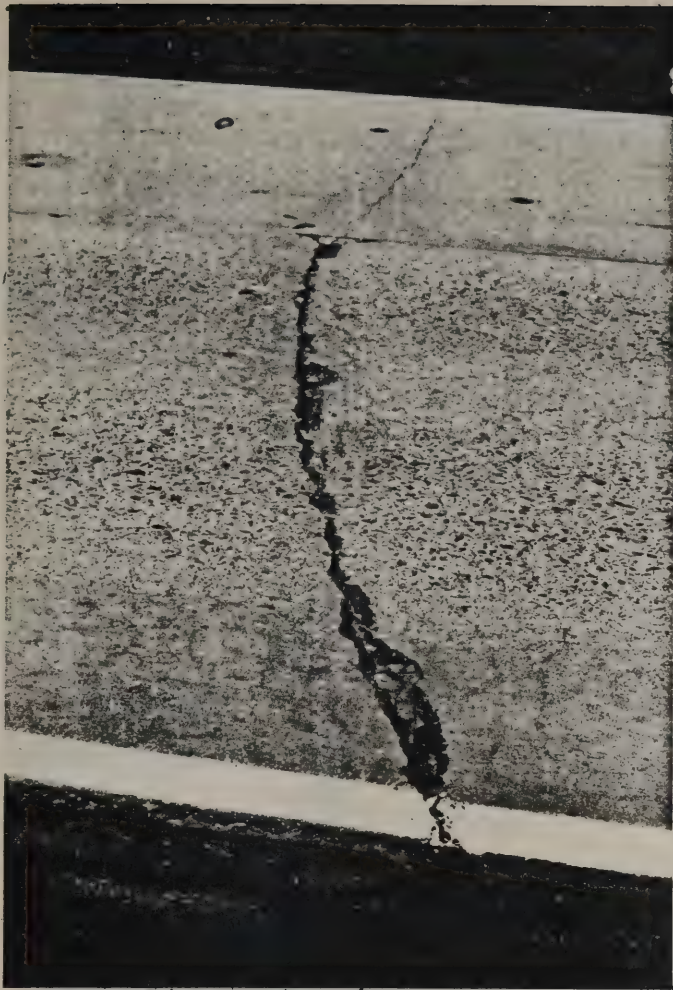
PHOTO 5

Wide, "Working" Mid Slab
Crack Which Has Faulted
and Spalled

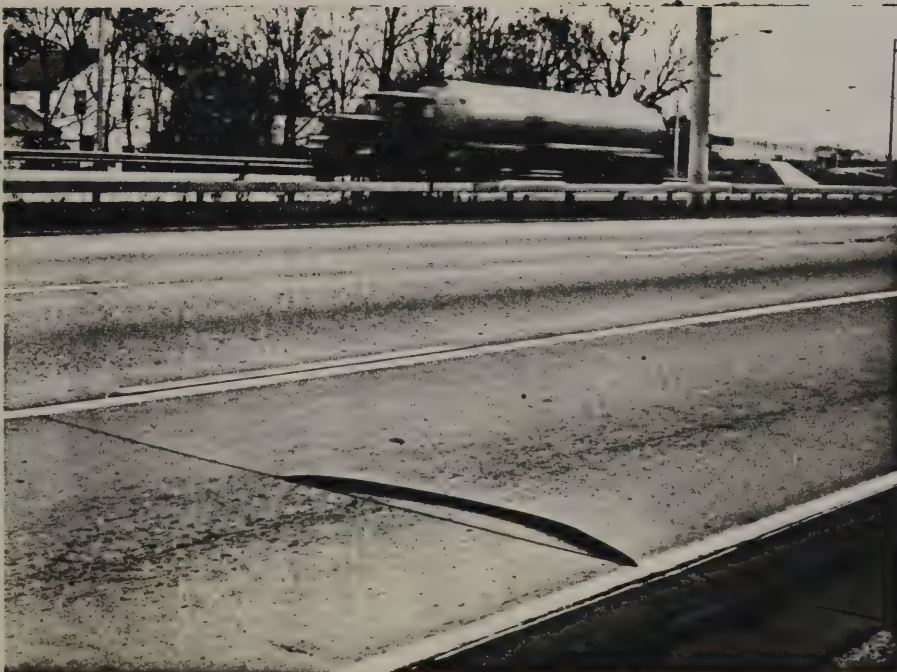
PHOTO 6

A Failed Preformed
Neoprene Extrusion
Lost From a Trans-
verse Contraction
Joint

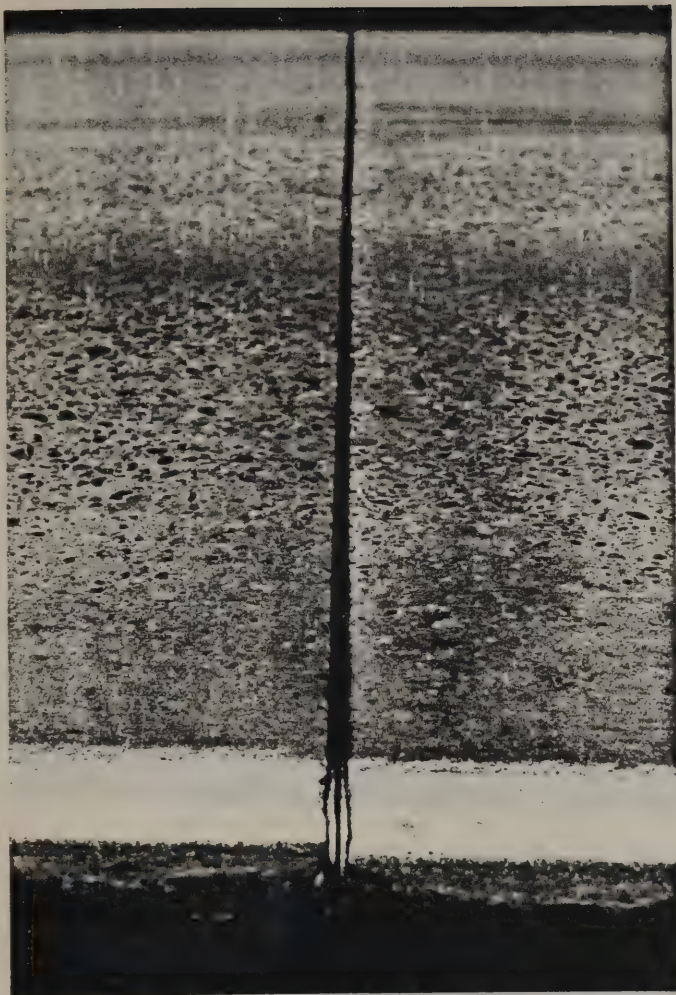
PHOTO 7

A Preformed Neoprene Extrusion
Still Sealing a Transverse
Contraction Joint

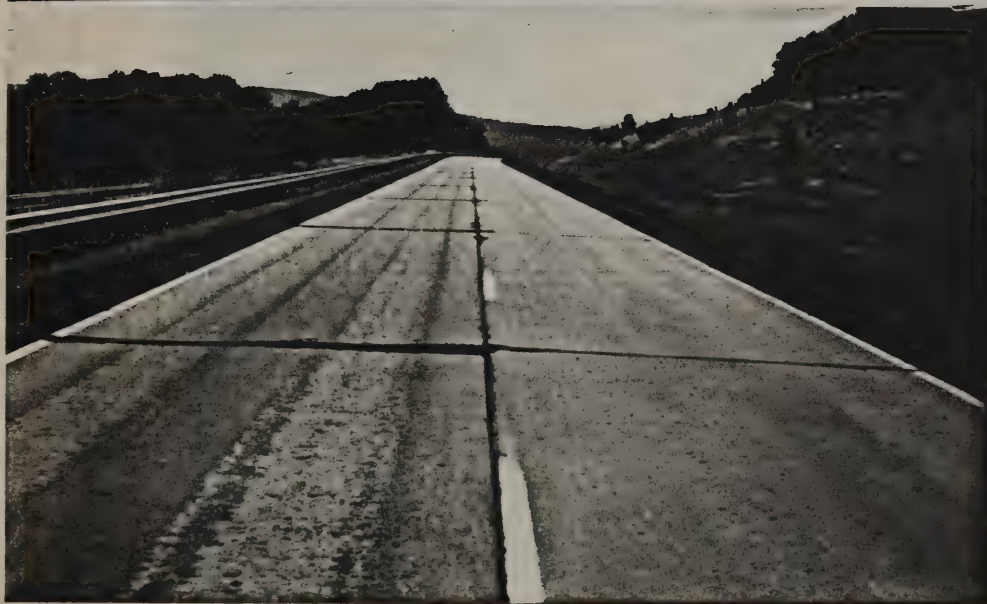
PHOTO 8

View toward oncoming traffic.
Wheel track Ruts in the Driving Lane.
Note, the Transverse Joint Faulting
that has occurred in this lane also.

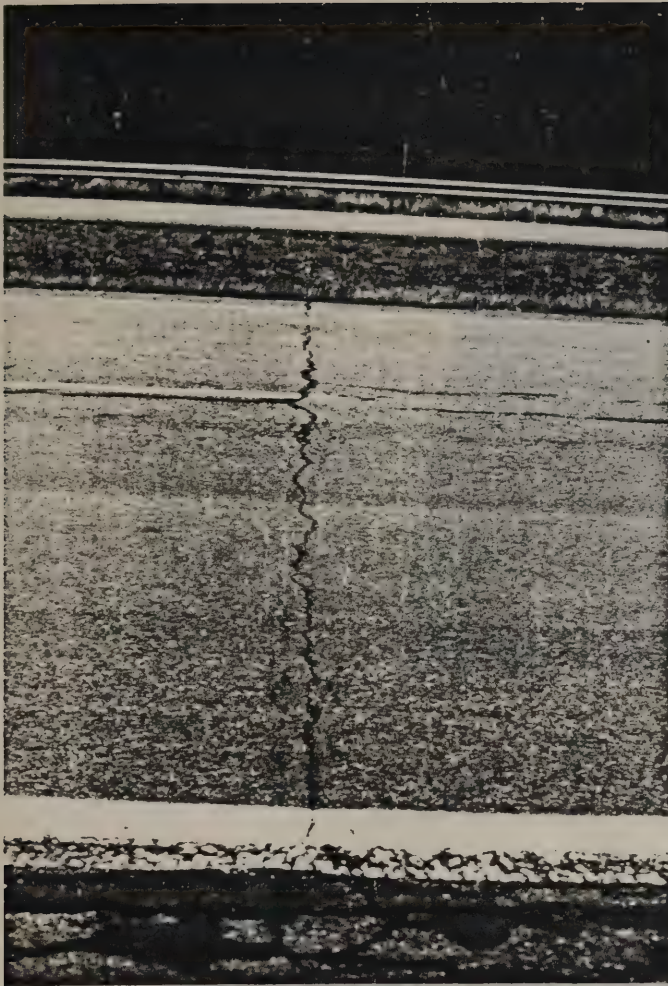
PHOTO 9

Transverse Reflective
Cracking in an Asphalt
Overlay

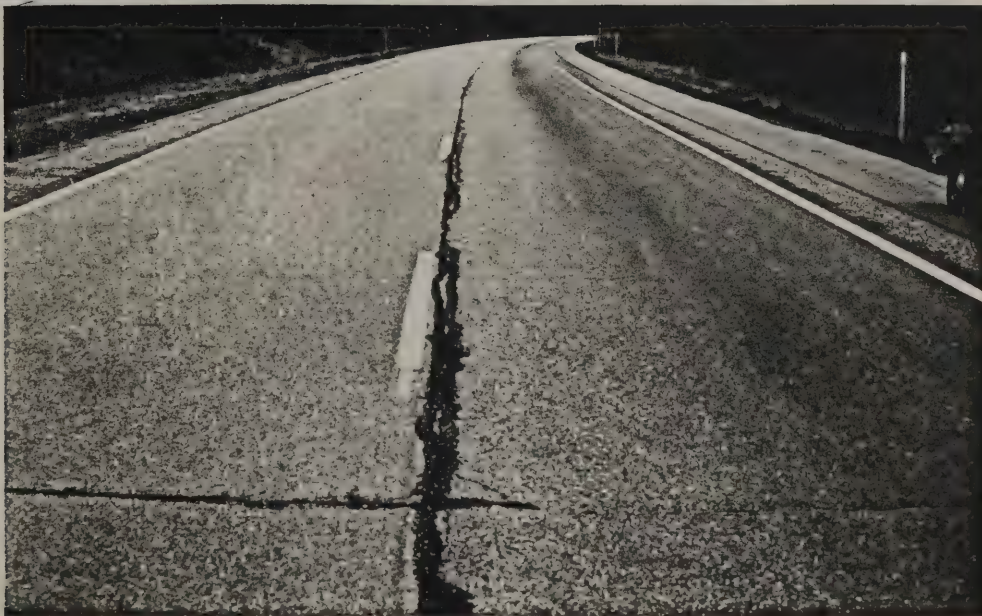
PHOTO 10

Longitudinal Reflective Cracking
in an Asphalt Overlay, Patched By
Maintenance Forces.

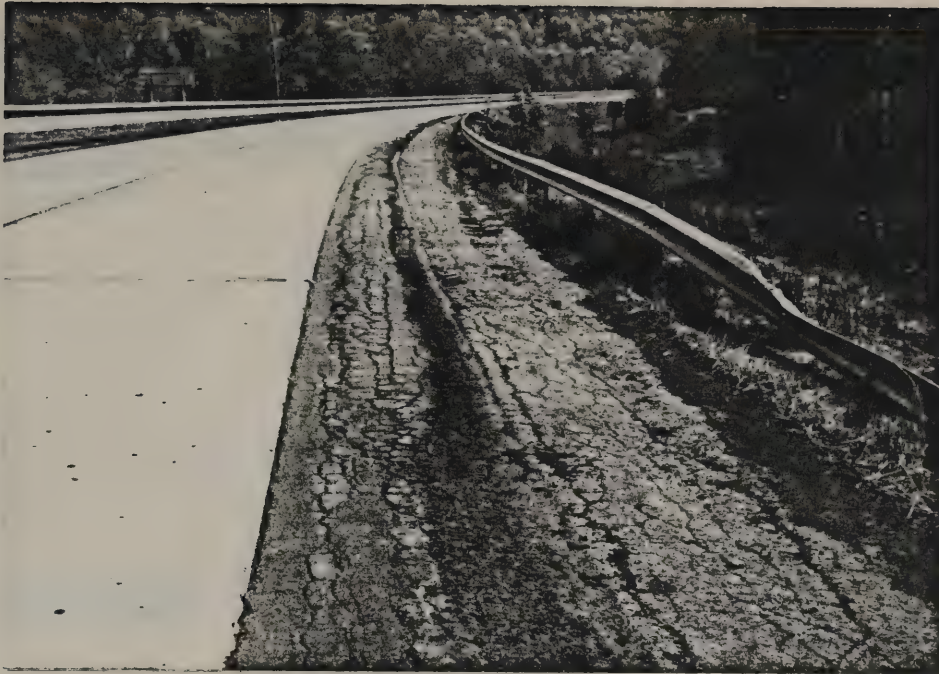
PHOTO 11
Alligator cracking and sand accumulation
along outside edge of shoulder.

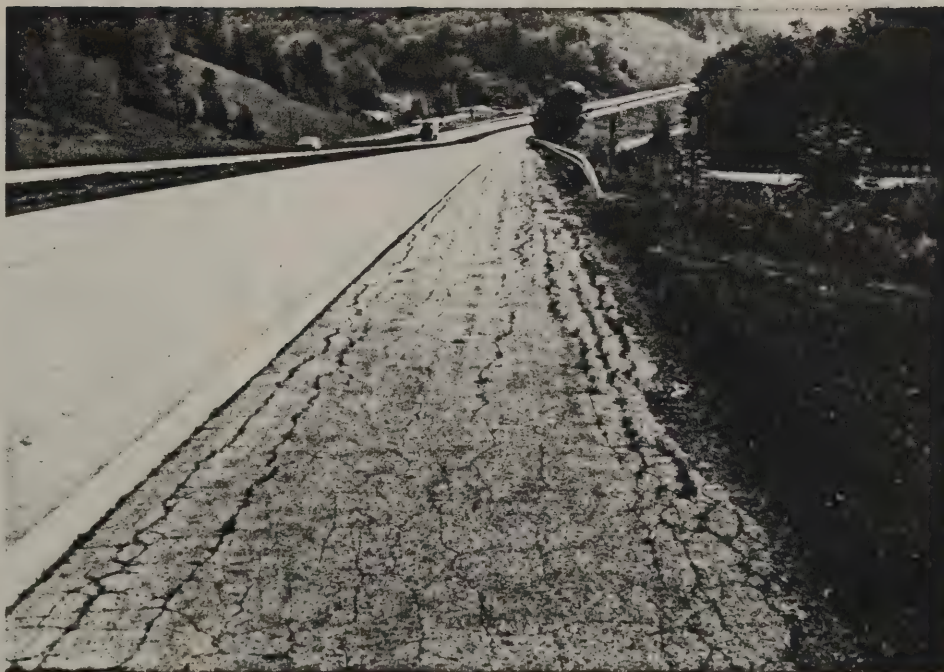
PHOTO 12
Alligator Cracking

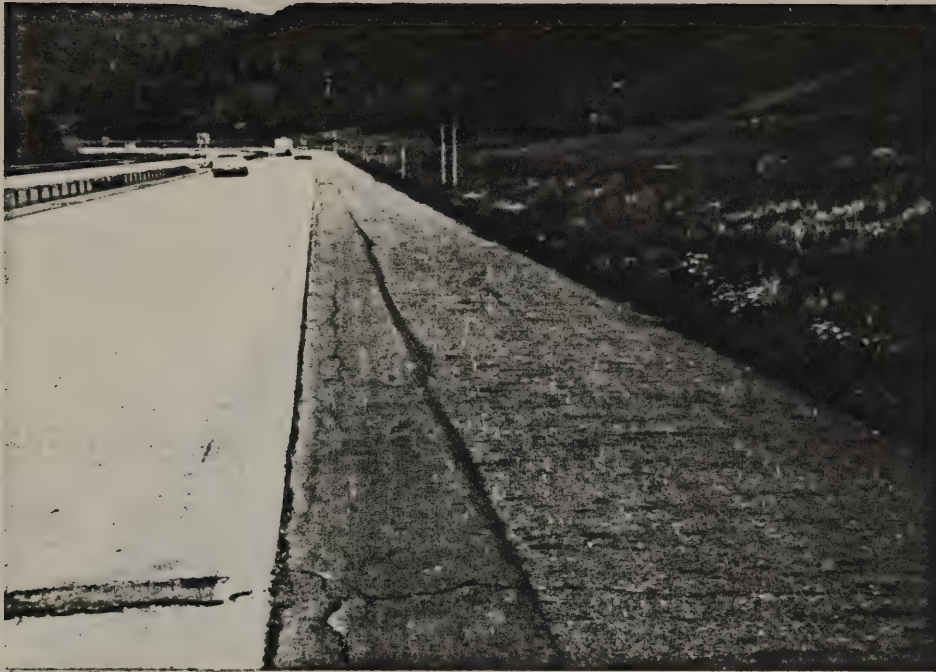
PHOTO 13
Two to three foot wide shim course
at the pavement shoulder interface.

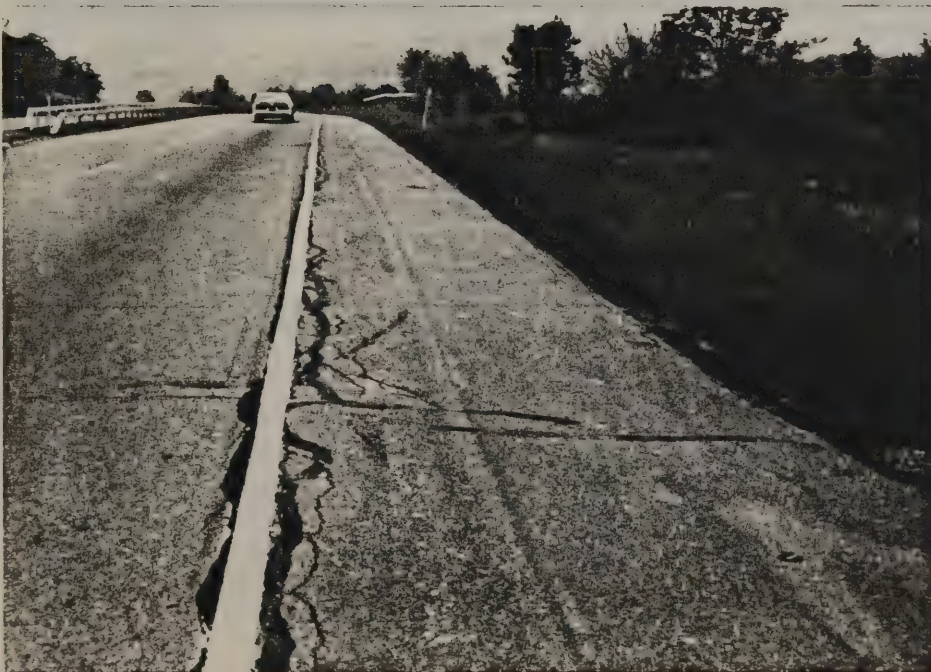
PHOTO 14
Attempt at sealing cracks along
the pavement shoulder interface.

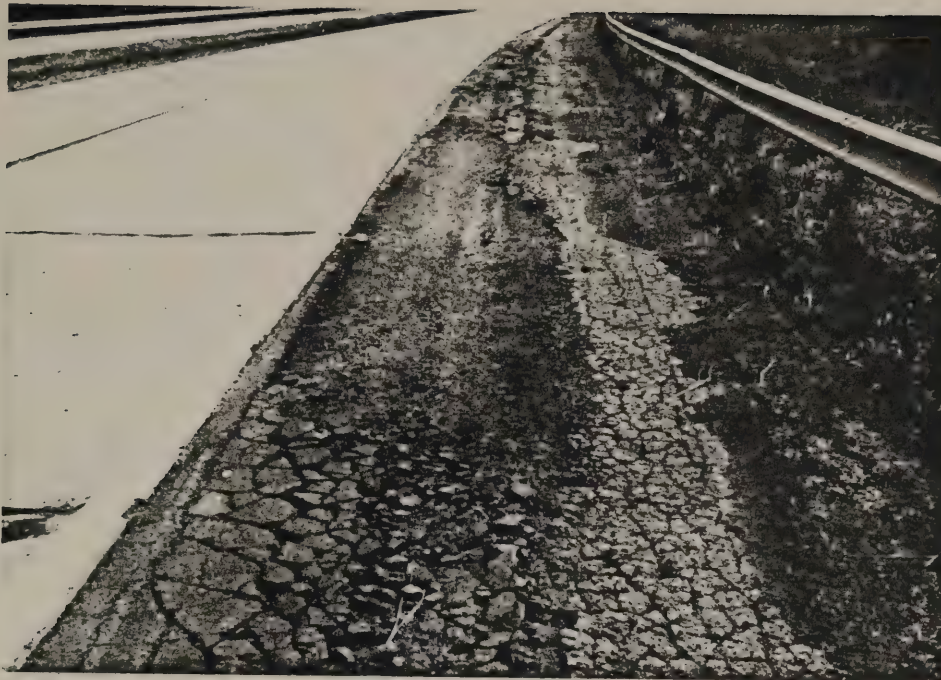
PHOTO 15
Completely disintegrated shoulder with
droff at pavement shoulder interface.

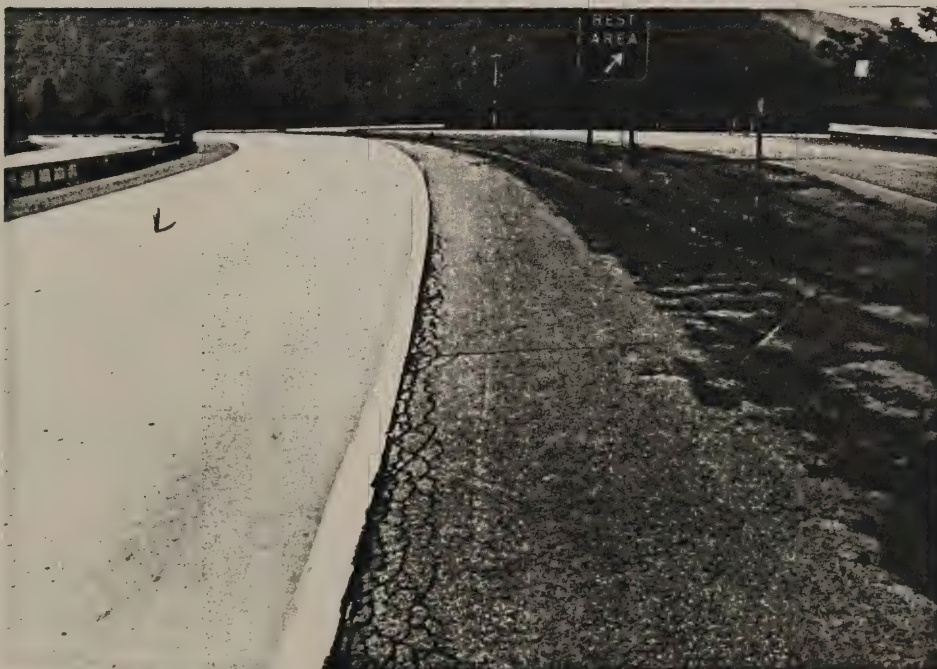
PHOTO 16

Typical cracking one to two feet
in from the pavement shoulder interface.
